Manhole Inspection Summary

Manhole # S29YY_013MH

Insp Date: **10/9/08 1:41 PM**

Location Address: **3330 GILMAN TERR**

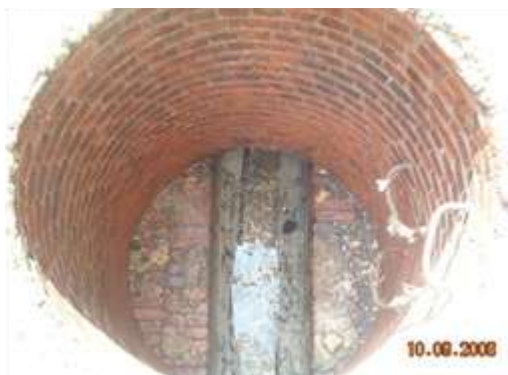
Top View

Corroded steps. Evidence of surcharge - Bench debris.

Concrete lid removed

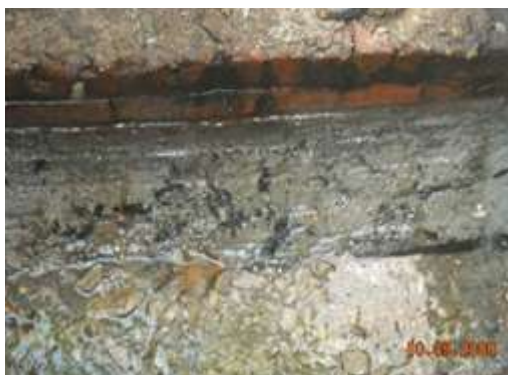
Defect

Condition: ☐ Sound ☐ Cracked ☐ Root Intrusion ☐ Deteriorated ☒ **Leaks** ☐ Debris

Channel leaks.

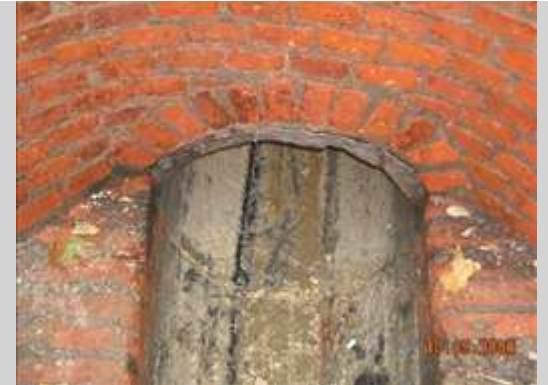
21 in. Circular Gravity Sewer Pipe Out @ 12 O'Clock

Deposits: ☐ None ☐ Mud ☐ Sludge ☐ Debris ☒ **Grease**

Silt Depth: **0** (in.) Deposits Extent: **Light**

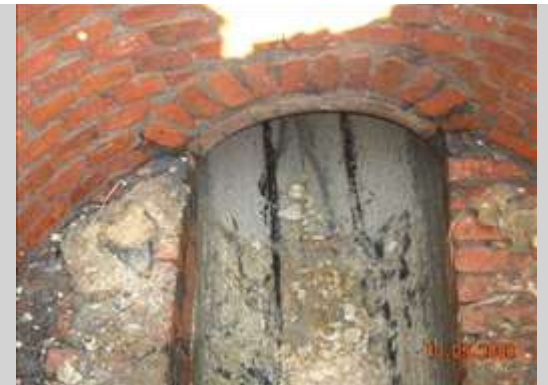
21 in. Circular Gravity Sewer Pipe In @ 6 O'Clock

Deposits: ☐ None ☐ Mud ☐ Sludge ☐ Debris ☒ **Grease**

Silt Depth: **0** (in.) Deposits Extent: **Light**
